# Wetland Reserve Easement Management Plan

## Natural Resources Conservation Service

| <b>Landowner:</b><br>Wings Over Wisconsin | |

## Supplement: WREP Management Recommendations

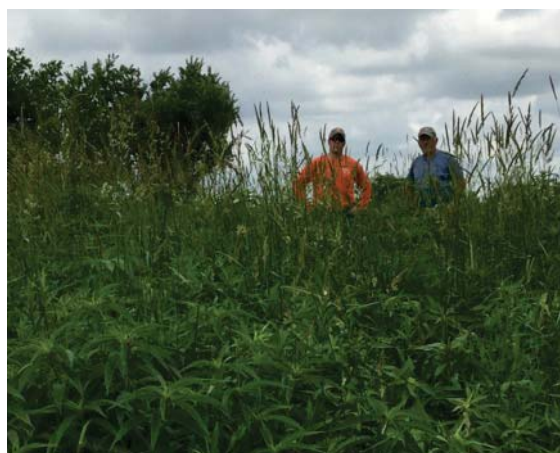
*Two active members of Wings Over Wisconsin stand on top of the mound in rare calcareous fen that's located in southwestern corner of site. This unique habitat needs to be carefully managed to prevent degradation.*

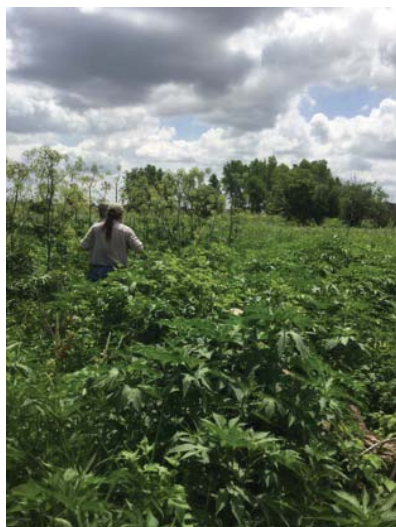
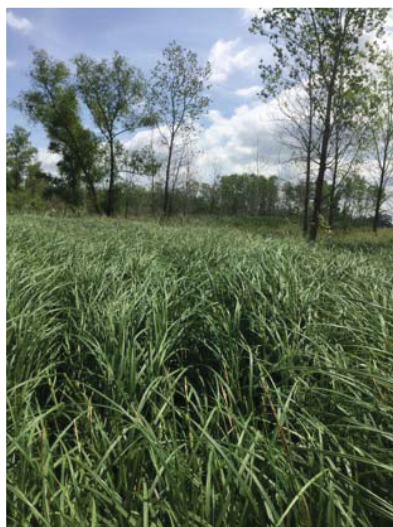
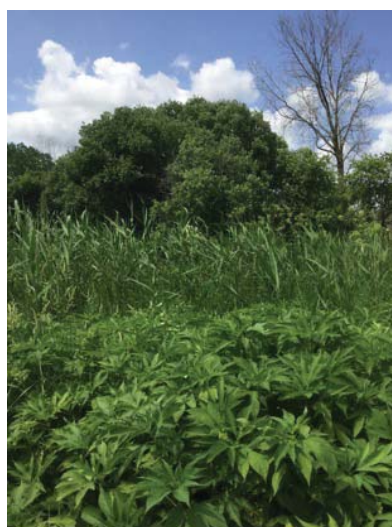
*RCG, giant ragweed, and Phragmites dominate fresh (wet) meadow areas, but small patches of native sedges, such as lake sedge (middle photo) and native grasses (e.g., bluejoint grass) can be found.*

3. **Reduce the biomass of hybrid cattail, RCG, and Phragmites** throughout WREP site by allowing the landowner to hay or mow during drawdowns or other desired/effective times. Prescribed burning of mowed areas dominated by hybrid cattails is an effective way to remove biomass and create open water conditions in the fall. Haying and prescribed fire may be impractical in the deeper water scrapes – unless new and/or improved water control structures are implemented. Managed grazing is likely the most practical way of managing the RCG in areas that are too wet for equipment access, but would need to be carefully designed and monitored. Periodic short-duration grazing as early in the growing season as possible would provide the greatest benefits. A detailed map of invasive-dominated areas is in the ERC plan.

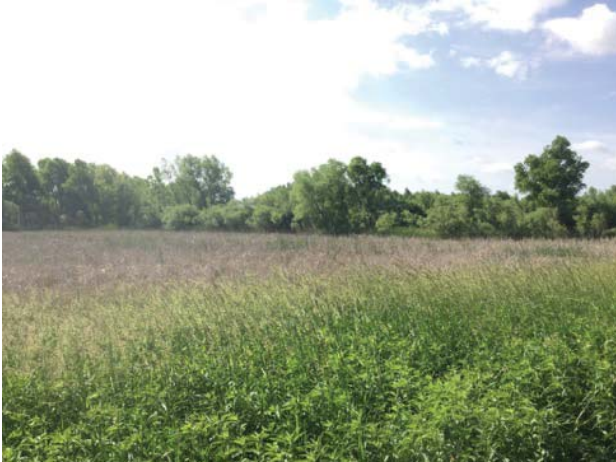
*Fresh (wet) meadow degraded by RCG.*

1. **Expand annual mowing activities** to include current trail locations and other areas infested by invasive plants. Mowing activities should be extended to all areas where RCG is present and conducted as early as possible during the growing season. These activities should occur annually and be monitored to determine effectiveness.
2. **Develop and implement a drawdown schedule** to facilitate water level fluctuations and invasive plant control throughout the site. Invasive plants management will be much less effective if not combined with water level fluctuation. Controlled draining of the wetland in late summer may help equipment access to the emergent wetland for vegetation management (cattail mowing, etc.).

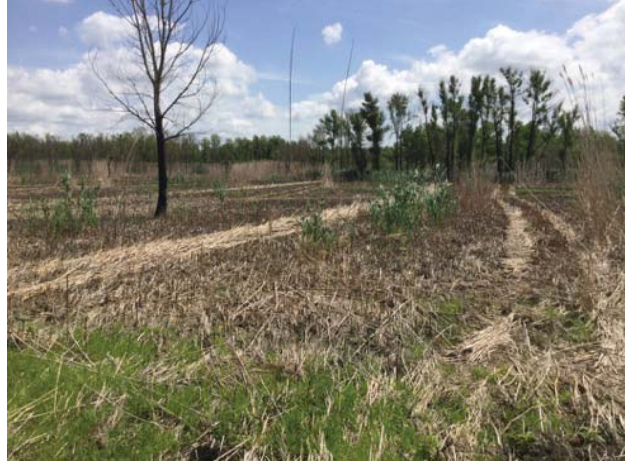
*Phragmites area managed by herbicide treatments.*

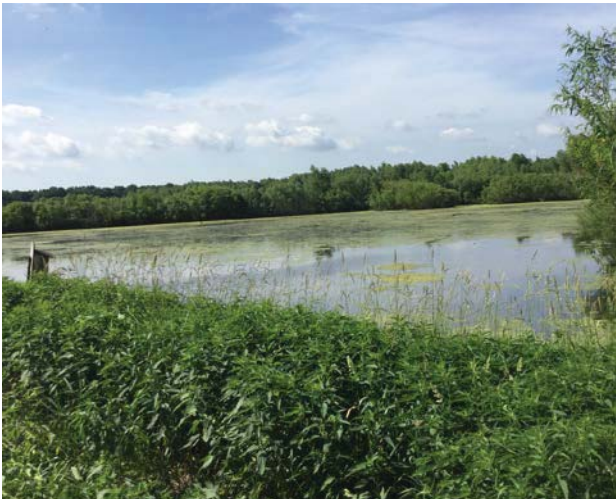
*Open water pools in emergent marsh areas are in relatively good condition and not extensively infested by hybrid cattail. These habitats would benefit from regular drawdowns and water level fluctuations.*

As a rule of thumb, water levels should be held high in the spring and slowly released to the lowest level possible in late August to early September. Water levels can be raised back to full pool by the end of September. Total summer drawdowns should be implemented approximately every five years.

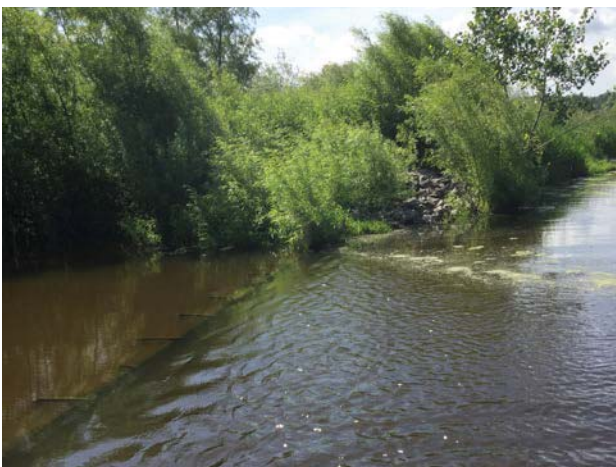
| Embankment/Water Control Structure | |
|---|---|
| Structure Guidance: | Structure no longer provides water level control and thus should be used to provide passive water flow into wetland. The development of a new structure allowing water outflow should be installed to facilitate water level fluctuation and periodic summer drawdown actions. The possibility of installing additional water intake structures along the agricultural drainage ditch should be explored as funds become available. |

*Existing water control structure.*

The current water control structure alone is insufficient to effectively reduce the static water levels that are producing conditions most suitable for invasive plants. If funds become available, we recommend that the current water control structure be left in place, and that it be supplemented with the installation of an additional structure along the eastern boundary of the easement. The two structures will allow water flow across the emergent wetland area and will help develop the ability to conduct periodic drawdowns. The possibility of placing one or more additional water delivery structures in the agricultural drainage ditch that flows along the northern boundary should be explored. The structures could serve to direct drain flows into wetland areas at strategic locations, providing more water control than is currently possible.

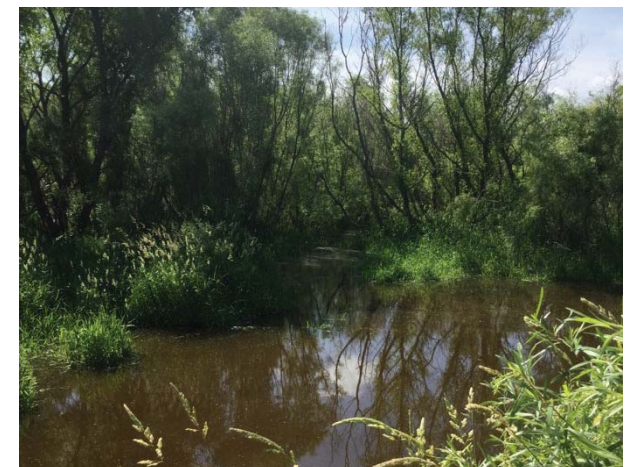
*Dike along northern edge of property is breached and allowing consistent inflows from drainage ditch and Mauneshia River.*

- **Repair the dike breach along northern edge of property**
- **Install new water control structures** to enable more of the site to be flooded during planned water level fluctuations and give more control over the site's inflows and outflows.

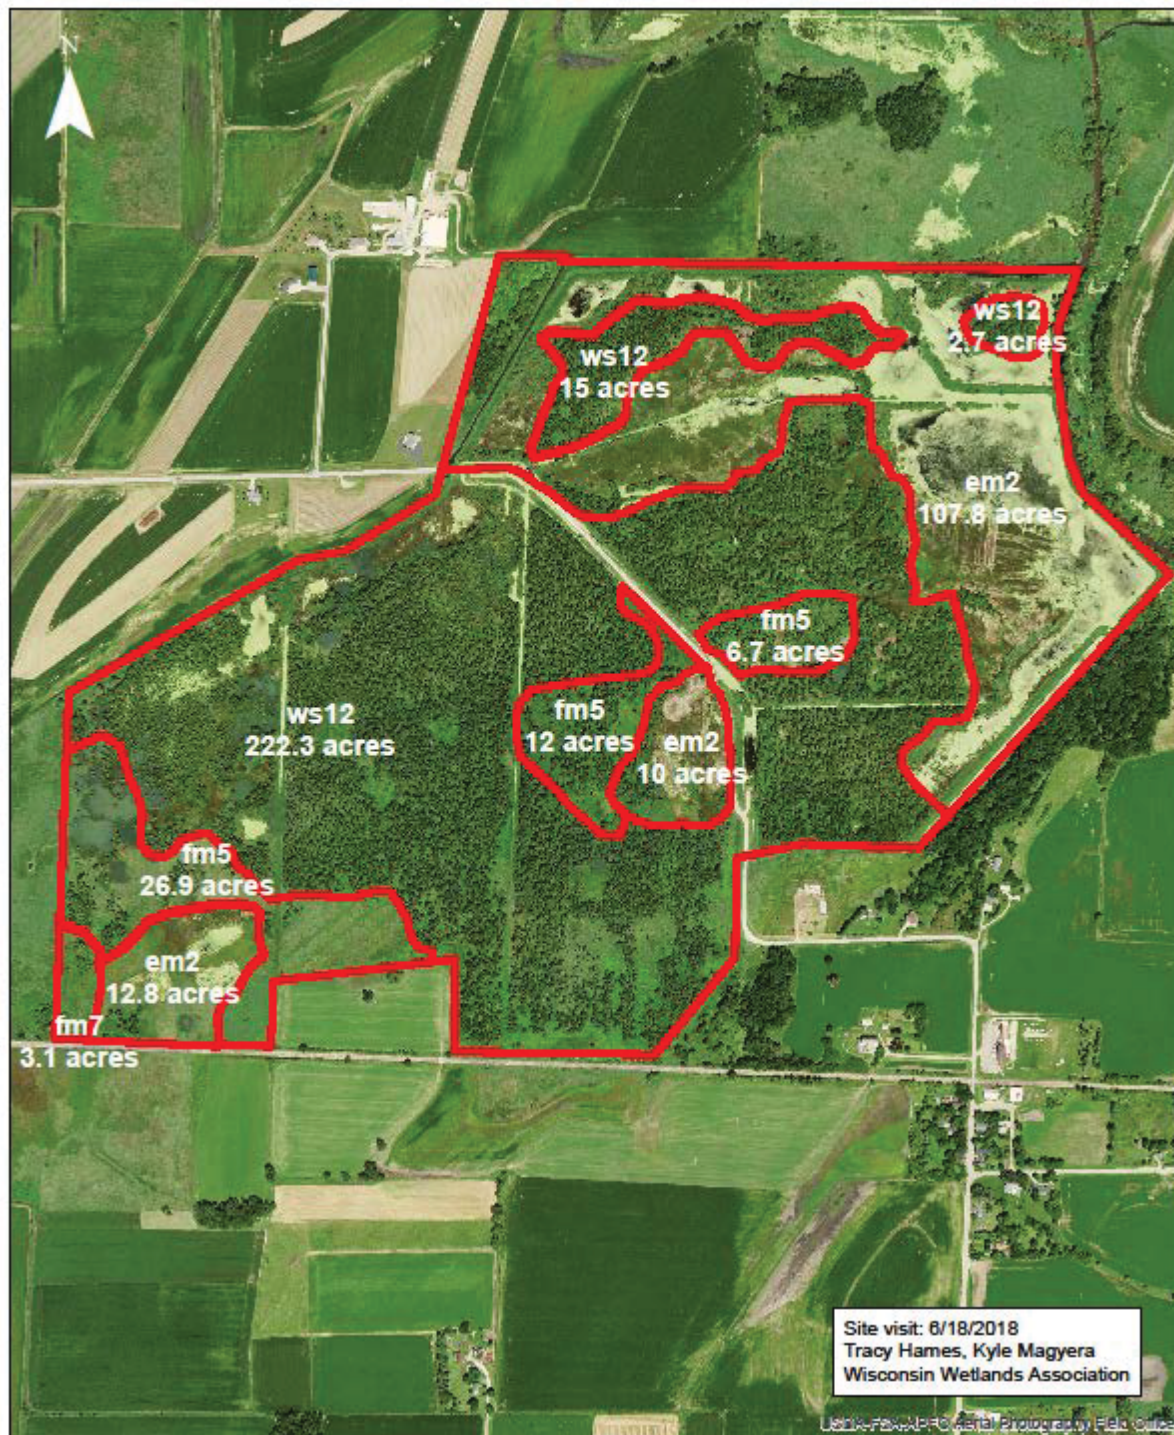
# Tri-County W.O.W. Phragmites, and Invasive Cattails Extent Jan 2016

| Phragmites Under Cover | 37.18 |
| Phragmites In The Open | 13.59 |
| Invasive Cattails | 38.64 |
| Fen | 2.2 |
| Open Water | 46.96 |
